LIGHTING AND INDICATOR SYSTEM

F700 HEADLAMPS (Fig. 31)

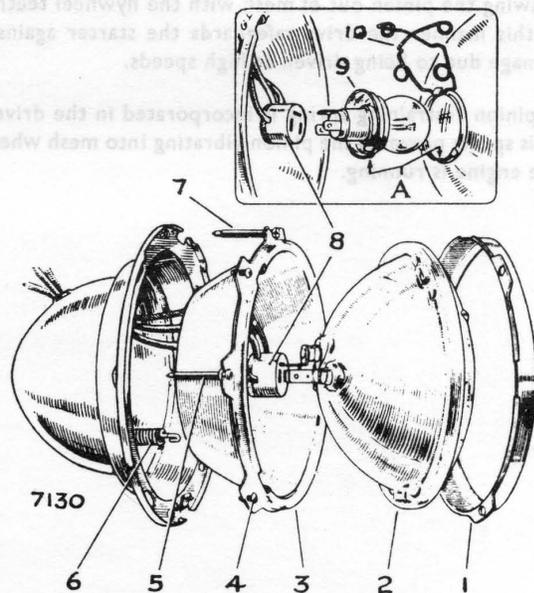
Fig. 31. F700 headlamp details

Models employing two separate headlamps incorporate 7 in. (17.8 cm.) diameter sealed beam light units. Each light unit is of all-glass construction with an internally aluminised glass reflector fused to the front lens.

Two filaments are contained in each unit, one for the main beam and the other for the dipped beam. These are installed with absolute care and precision before they are finally sealed in the gas-filled chamber which comprises the light unit.

- 1. RETAINING RIM
- 2. SEALED BEAM LIGHT UNIT
- 3. SEATING RIM
- 4. RETAINING RIM SCREW
- 5. LATERAL ADJUSTING SCREW
- 6. TENSIONING SPRING
- 7. VERTICAL ADJUSTING SCREW
- 8. SLOTTED CONNECTOR PLUG
- 9. BULB
- 10. BULB RETAINER } EUROPEAN TYPE
- A. LOCATION FOR BULB

Gently prise the front (painted) rim from its securing clip which is positioned at the lower and "peakless" half of the rim.

Remove the three cross-head screws securing the retaining rim, which are accessible on removal of the dust excluding rubber; the Sealed Beam unit can then be withdrawn and detached from the slotted connector-plug.

Each headlamp is provided with two adjusting screws, the adjusting screw (7) provides adjustment in the vertical plane whilst the adjusting screw (5) provides adjustment in the lateral plane.

This type of sealed headlamp is so designed that adjustment can be accurately undertaken using a spirit-level type beam setter. Three glass "aiming pads" take the form of projections moulded integrally around the outer front edge of the lamp glass, where their purpose is to provide a reference plane for beam aiming.

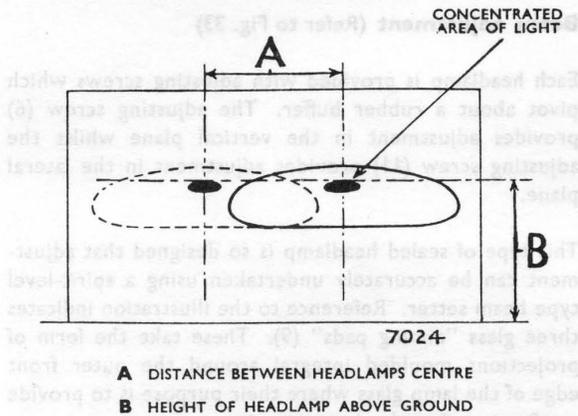
Fig. 32. Headlamp alignment

If the use of neither type of beam setter is available, a fair degree of accuracy can be attained by use of an aiming board (Refer to Fig. 32).

1. Ensure that the car is parked (handbrake on) on level ground.
2. Ensure that the front of the car is parallel with the aiming board which is to be positioned at a distance of 25 ft. (7.62 m.) from the car.
3. Either load the car with two adults or simulate this load by adding weights to the car.
4. Clean the glass of one lamp.
5. Adjustment is to be commenced at one lamp; mask the remaining lamp.

6. Turn the adjusting screws clockwise to their full extent.
7. With the lamp illuminated in the main beam condition, turn the adjusting screws anti-clockwise as necessary until the required setting is achieved.
8. Remove the mask from the remaining lamp and mask the lamp which has been set.
9. Clean the glass of the lamp.
10. Turn the lamp adjusting screws clockwise to their full extent.
11. With the lamp illuminated in the main beam condition turn the adjusting screws anti-clockwise as necessary until the required setting is achieved.
12. Recheck the setting of both lamps.

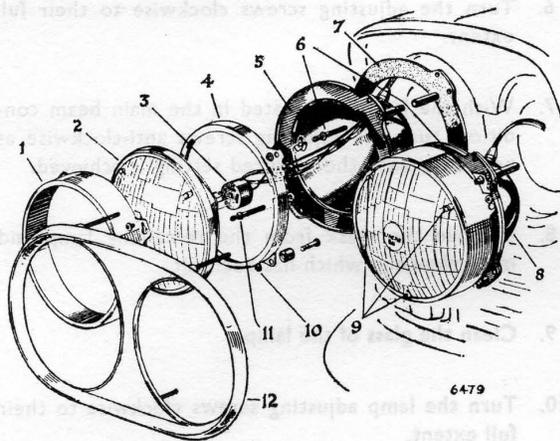
Fig. 33. F575 dual headlamps—exploded view

Two pairs of headlamps are employed in this arrangement, each pair being of 5½ in. (12.8 cm.) diameter. The inboard lamps are fitted with single main beam filaments whilst the outboard lamps are each fitted with a meeting beam filament and a supplementary main beam filament.

| 1. FRONT RIM | 7. GASKET |
| 2. LAMP UNIT (2A) | 8. LAMP BODY |
| 3. ADAPTER | 9. AIMING PADS |
| 4. SEATING RIM | 10. RETAINING RING |
| 5. LAMP BODY | 11. BEAM ADJUSTMENT SCREW (LATERAL) |
| 6. BEAM ADJUSTMENT SCREW (VERTICAL) | 12. BEZEL |

Remove the lamp bezel retaining screws and detach the bezel from the lamps.

Slacken the three cross-head screws securing the lamp and rim and turn the rim slightly in an anti-clockwise direction which will align the larger end of the three key-hole slots, in the periphery of the rim, with the screw heads.

Release the rim and lamp unit. The lamp can be completely removed after disconnecting the wiring adaptor.

Each headlamp is provided with adjusting screws which pivot about a rubber buffer. The adjusting screw (6) provides adjustment in the vertical plane whilst the adjusting screw (11) provides adjustment in the lateral plane.

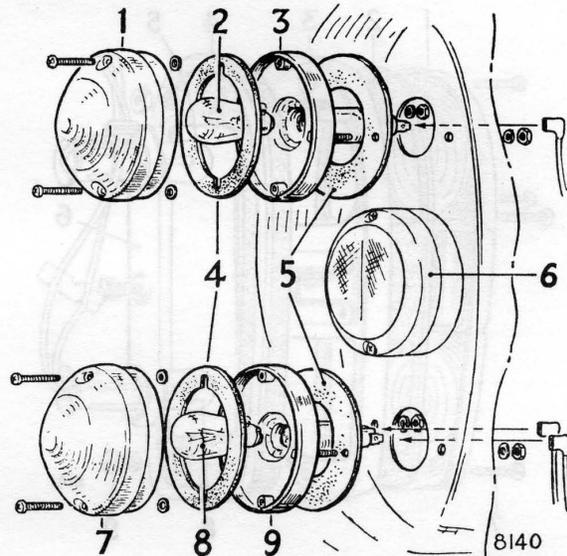
Fig. 42. L692, L691 and RER31 lamp arrangement

These are separate units fitted to form a cluster on an oval-shaped panel. To renew any one bulb, remove two securing screws from the particular lens and withdraw the lens. The bulb can now be removed and a new one fitted. The stop/tail lamp has a double filament bulb which is formed with offset locating lugs to ensure correct assembly.

| 1. AMBER LENS | 6. REAR REFLECTOR |
| 5. LAMP SEAL | |

To remove the lamp units, unscrew the nuts at the rear of the lamps, disconnect the cables at their Lucar connectors and withdraw the lamps. Reassembly is a reverse of the dismantling procedure, but care should be exercised to properly locate the rubber sealing washers.

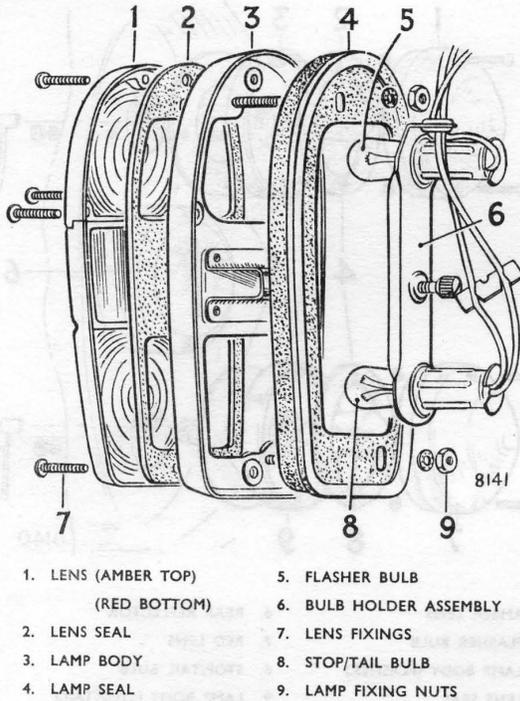
Fig. 43. L572 stop/tail and flasher lamp details

The two-piece lens on this unit can be detached without removing or dismantling the complete unit. To remove the lens, it will be only necessary to undo the four recessed screws, when the lens can be withdrawn. The complete unit is fixed to the rear panel by two hexagon nuts. Access to the nuts is obtained from within the luggage boot. On removing the nuts and disconnecting the cables, the unit can be withdrawn as an assembly.

A double-filament bulb for the stop/tail lamp, and a single filament bulb for the flashing indicator are mounted on a detachable bracket fixed to the rear of the unit by a knurled screw. To renew any one bulb, undo the screw and remove the bracket. The defective bulb can now be withdrawn and a new one fitted.

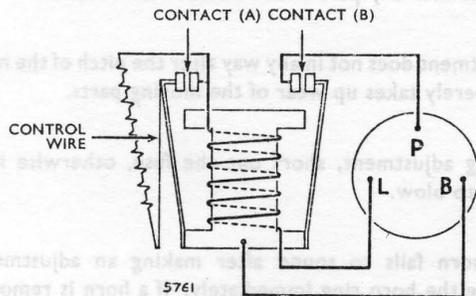
Fig. 44. Internal connections of flasher unit

It will be noted that in order to maintain the desired rate of flashing (British Ministry of Transport regulations, 60—120 per minute) the filaments of the front and rear lamps are "pre-heated" via the resistance wire during "out" period of the flash.

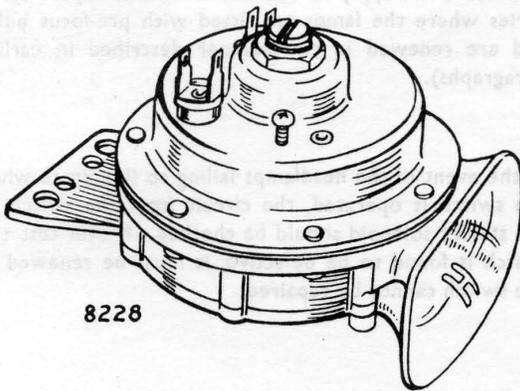
Fig. 45. Lucas model 9H horn

Method (i) Adjustment is provided by either a plain or a serrated screw which is located adjacent to the horn terminals. Rotate this screw in an anti-clockwise direction until the horn just fails to sound, then rotate it in the reverse direction for one quarter turn.

Method (ii) If a first grade 0—10 moving coil ammeter is available, connect it in series with the horn. A 9H model horn in correct adjustment will pass 3.0 to 3.5 amperes. Rotate the adjusting screw in a clockwise direction in order to increase the current and in the reverse direction to reduce it until the best performance is obtained within the stated current range.

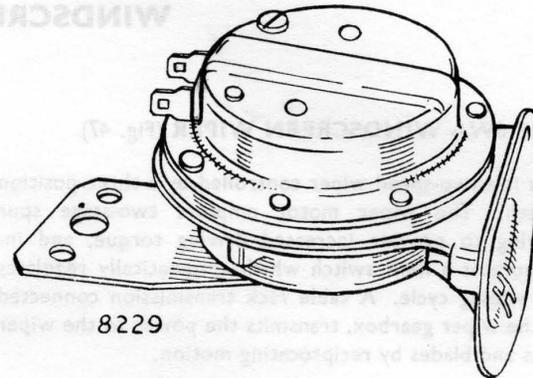
Fig. 46. Clear Hooter model F725 horn

Normally this condition is caused by insufficient current being drawn by the defective horn in which case the adjusting screw is to be rotated slowly clockwise until the volume of sound is restored, then rotate the adjusting screw slowly anti-clockwise to the point where the volume of sound is just maintained. At no time should the operating current exceed 3.5 amperes.

Usually this cause can be attributed to that of mal-adjustment or the presence of foreign matter between the contact points. In this instance the adjusting screw is to be rotated slowly in a clockwise direction for almost one half turn. Should the horn fail to sound after carrying out this adjustment, the screw is to be rotated in the reverse direction until the horn operates at the

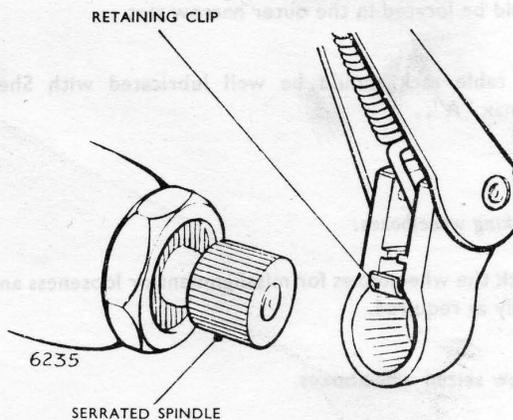
Fig. 50. Wiper blade and adjustment

To adjust the sweep of the wiper arms, remove and refit the arms in the manner described under the appropriate heading. The wiper gearbox limit switch cover is not to be used for this purpose.

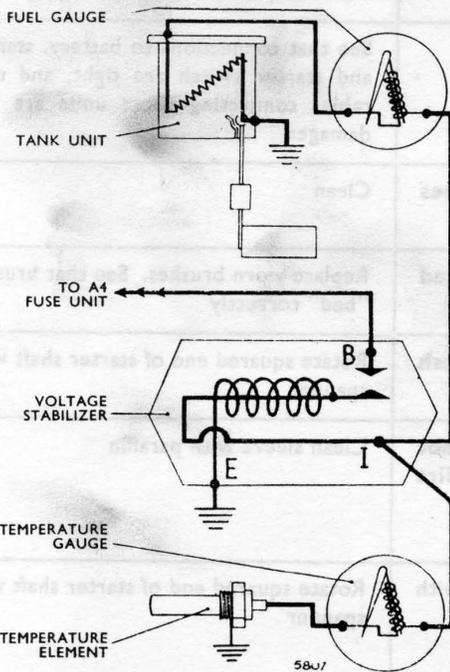
Fig. 51. Fuel and temperature indicators and voltage stabilizer

The system by which the equipment functions is voltage sensitive and the voltage stabilizer which serves both indicators is necessary to ensure a constant supply of a predetermined voltage to the equipment. The stabilizer is situated behind the instrument panel.

The mean voltage between terminal "I" and earth is 10 volts. Renew the stabilizer if faulty.

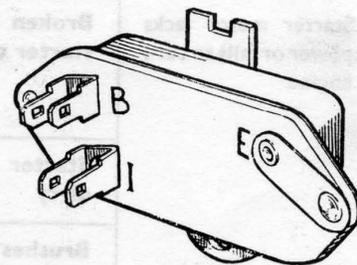
Fig. 52

Ensure that the stabilizer is mounted with its securing lug set vertically and the fixing hole downwards.

Ensure that the stabilizer is effectively earthed through its mounting lug.

Two types of voltage stabilizer to be found in service. Failure to observe the precautions will result in inaccurate instrument readings

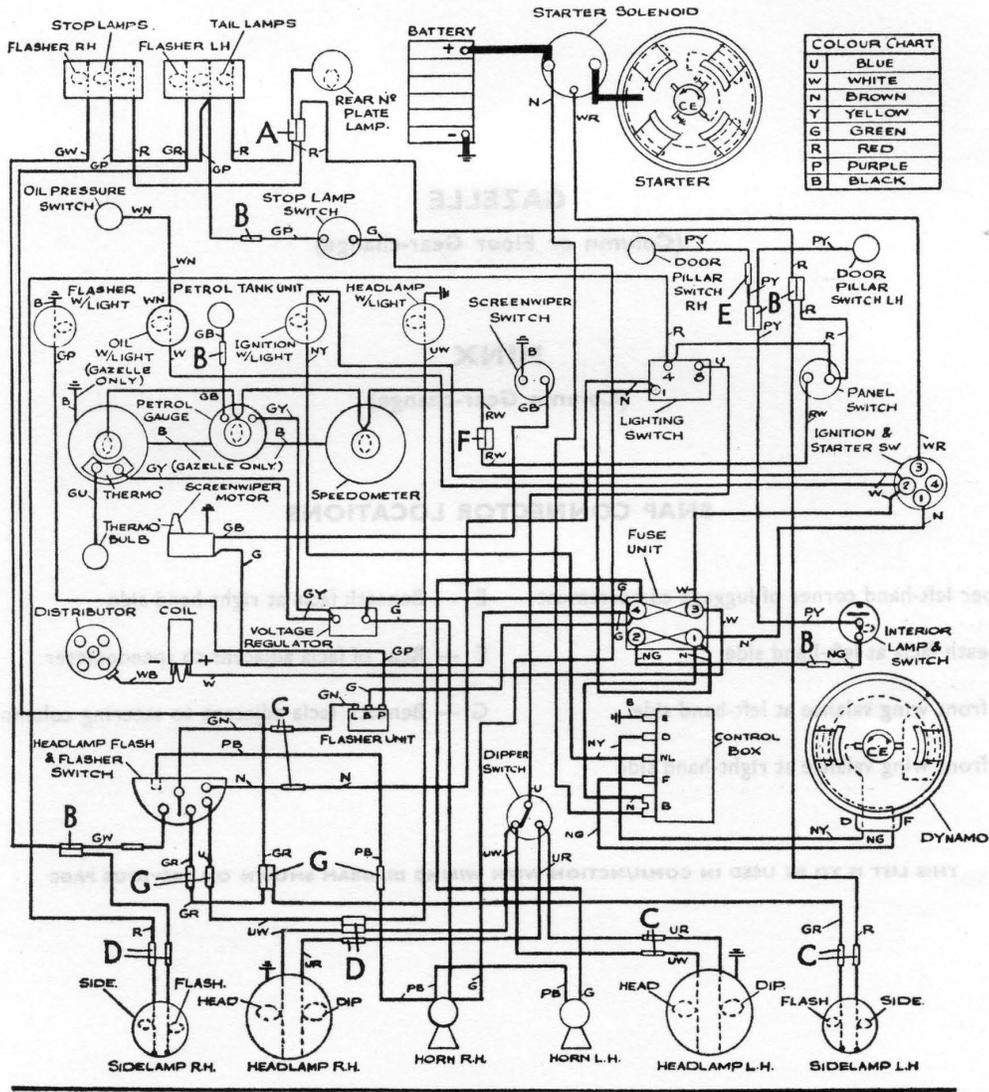
GAZELLE (Column or Floor Gear-change), MINX (Column Gear-change)
WIRING DIAGRAM

COLOUR CHART	
U	BLUE
W	WHITE
N	BROWN
Y	YELLOW
G	GREEN
R	RED
P	PURPLE
B	BLACK

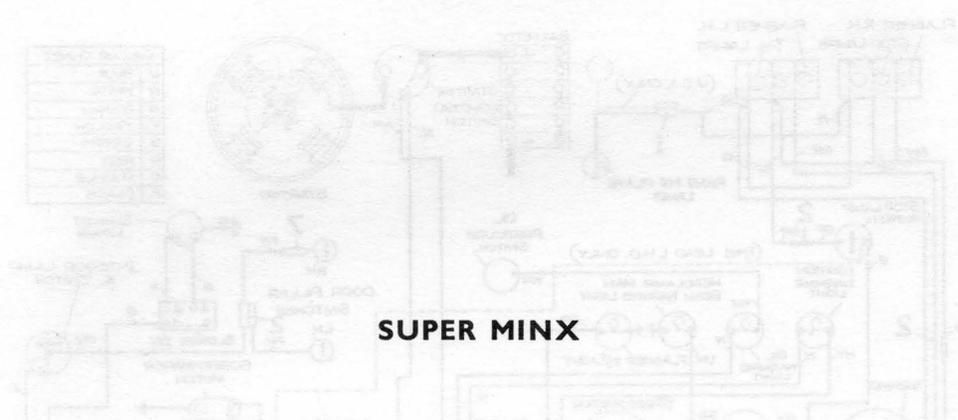
WIRING DIAGRAM
SUPER MINX

A LIST OF SNAP CONNECTOR LOCATIONS IS SHOWN OVERLEAF FOR USE WITH THIS WIRING DIAGRAM

SNAP CONNECTOR LOCATIONS

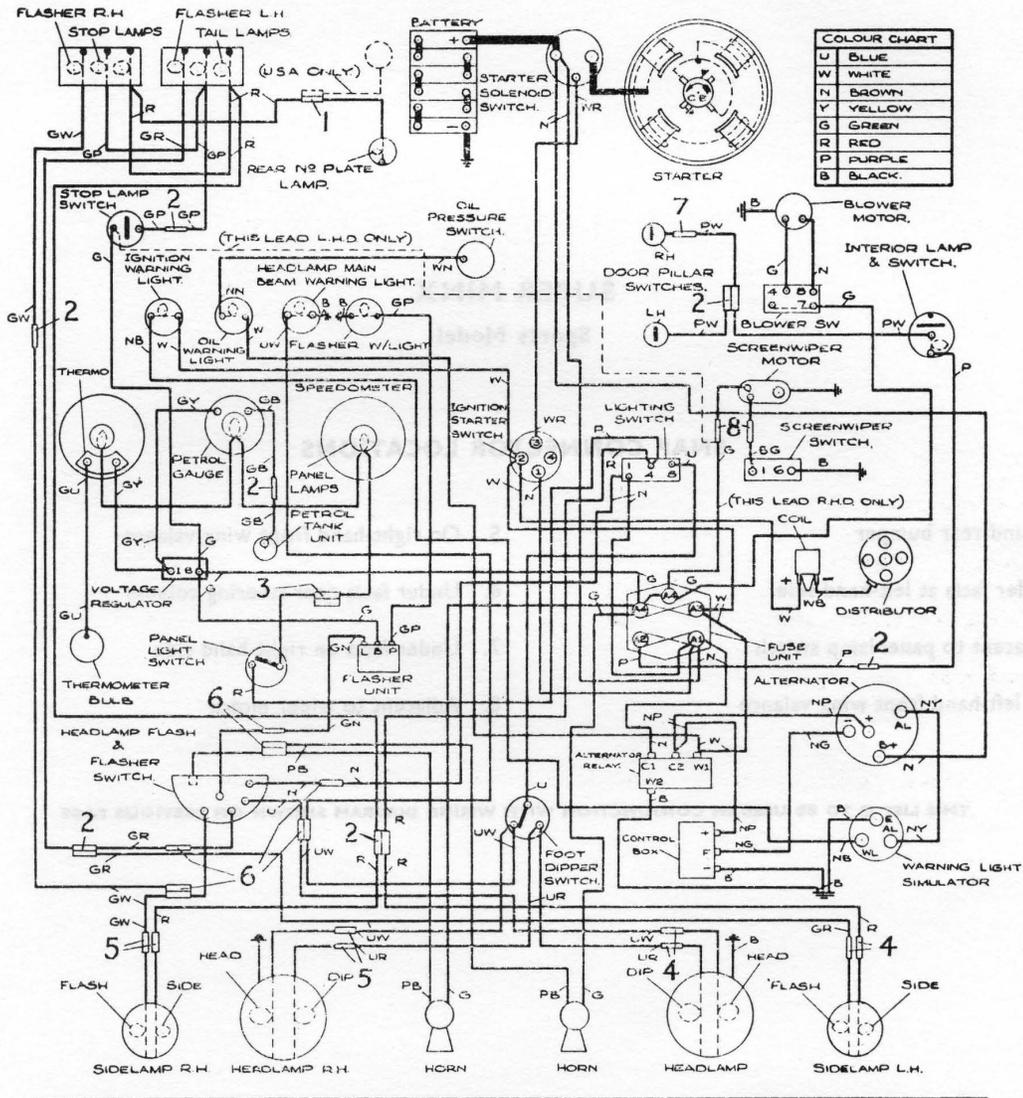
**SUPER MINX SPORTS MODEL
WIRING DIAGRAM**

COLOUR CHART	
U	BLUE
W	WHITE
N	BROWN
Y	YELLOW
G	GREEN
R	RED
P	PURPLE
B	BLACK

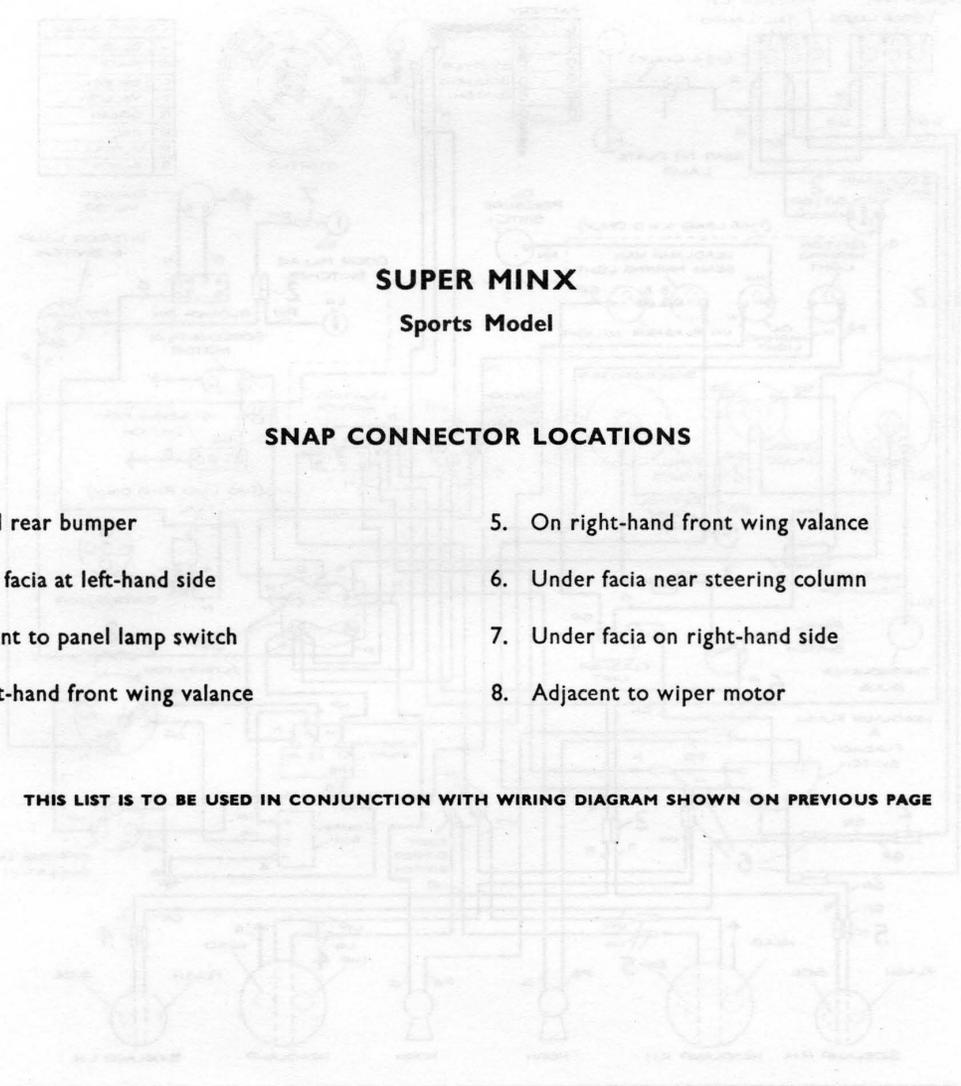
SCEPTRE WIRING DIAGRAM

A LIST OF SNAP CONNECTOR LOCATIONS IS SHOWN OVERLEAF FOR USE WITH THE WIRING DIAGRAM

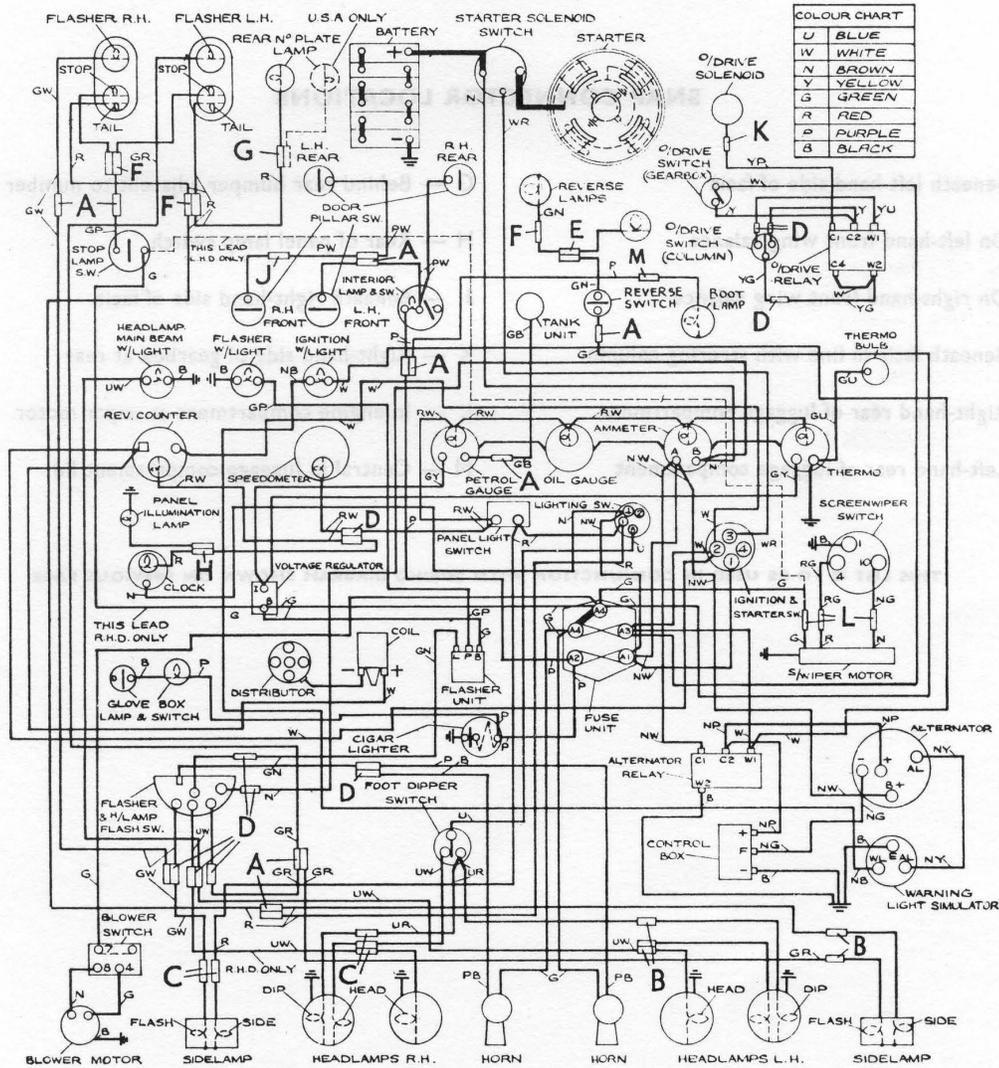
WIRING OF HEADLAMPS FOR R.H.D. MODELS AS SHOWN.
