Repair / Upgrade for Sunbeam Alpine Electronic Tachometer

By
Tom Hayden

(applicable to Series V tach models 2411/01 and Series IV models 2404/00A, and 2404/00B)

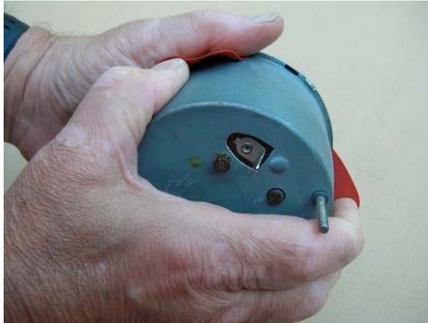
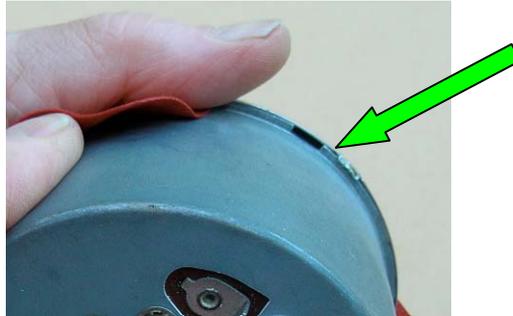
The first step is to disassemble the tach by removing the chrome ring and glass. This is done by rotating the chrome ring until the tabs line up with the slots in the case. It may be helpful to use a rubber pad such as used in the kitchen for removing tops of pickle jars. It may also help to bend the tabs slightly upward, but be careful so as not to distort the ring. Remove the ring, the glass, and the inside bezel.

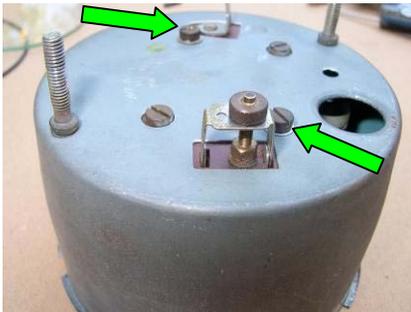
Next remove the 2 screws holding the assembly into the housing and carefully drop the assembly into your hand

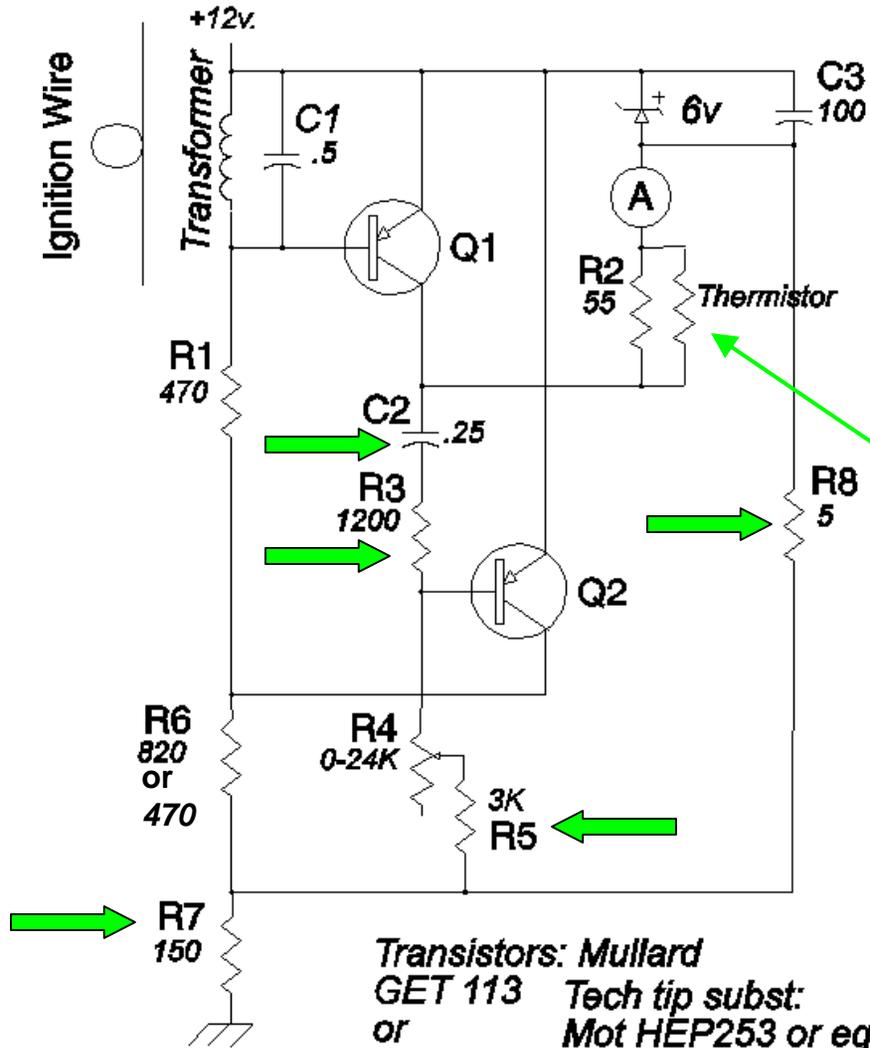
Smiths Tachometer

Transistors: Mullard
 GET 113 Tech tip subst:
 or Mot HEP253 or equiv.
 OC83B (eg. NTE158)

We need to replace:

- C2 with a new 0.22 uF cap
- R3 with a more stable modern Res 1.24 k
- R5 with a higher value modern Res 9.31 k
- R7 with a new, more stable, 150 Ohm
- R8 with a new stable 3.3 Ohm
- Old Thermistor with a combination, new (300 Ohm / 3900K) thermistor plus 34 ohms

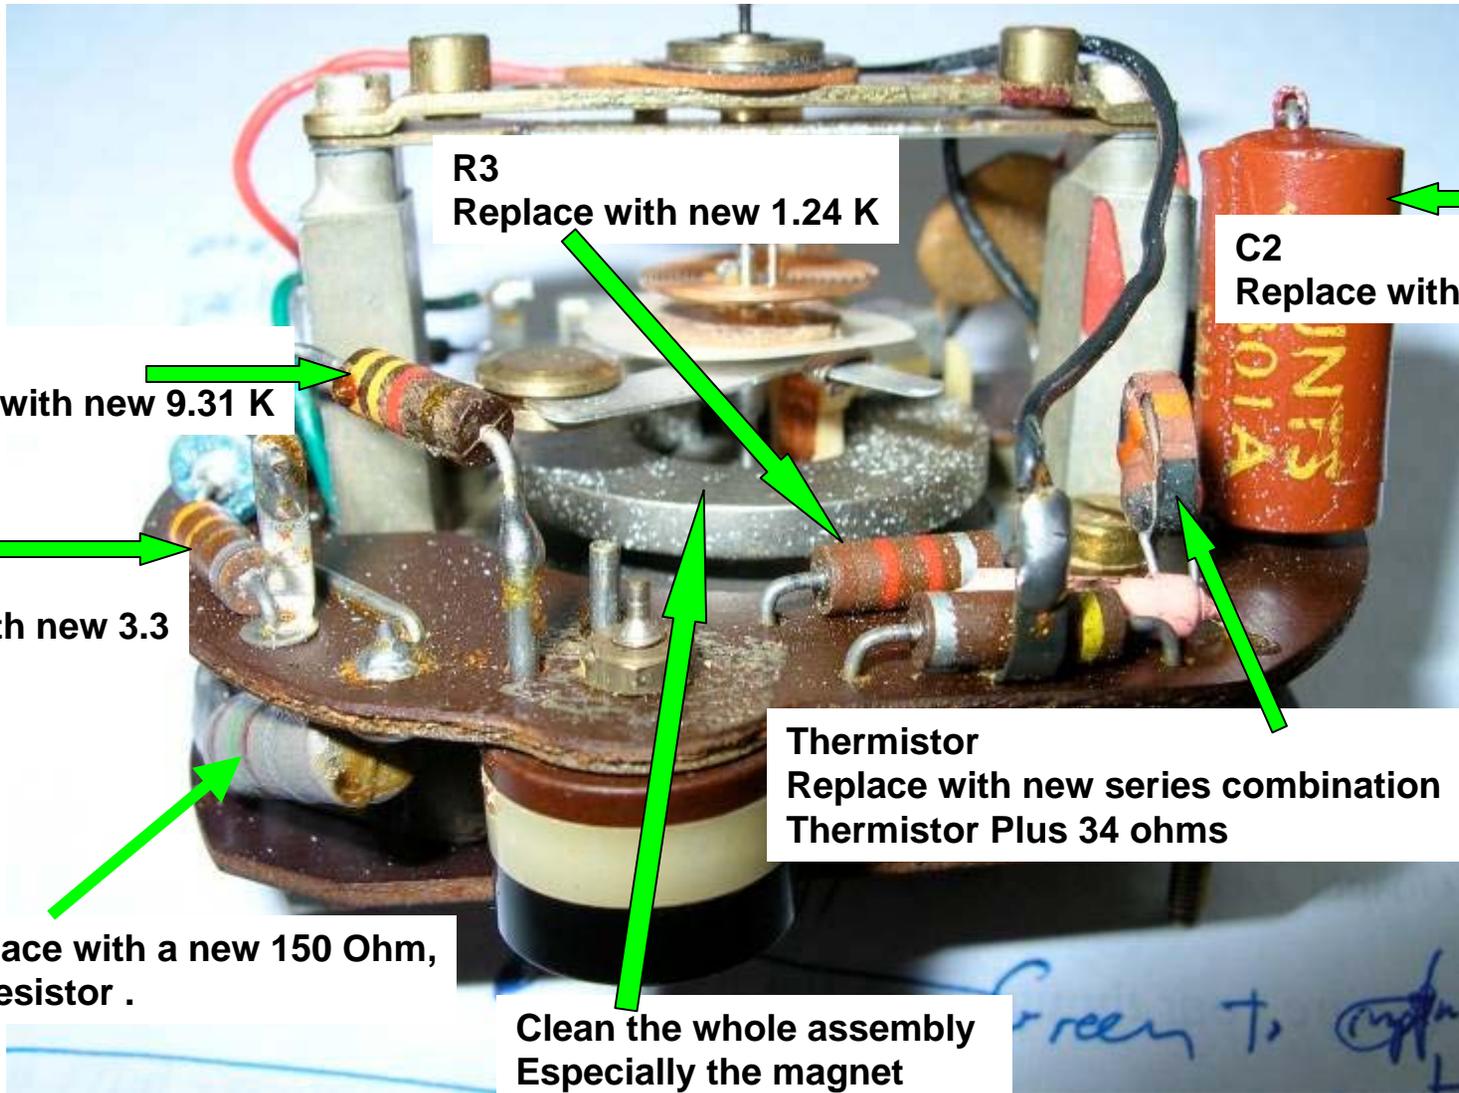
Original assembly

R3
Replace with new 1.24 K

C2
Replace with new 0.22uF

R5
Replace with new 9.31 K

R8
Replace with new 3.3

Thermistor
Replace with new series combination
Thermistor Plus 34 ohms

R7 Replace with a new 150 Ohm,
2 watt resistor .

Clean the whole assembly
Especially the magnet
CAREFULLY!
Use artists paintbrush and
Q-Tips, dipped in alcohol

Removing C2, R3, R5, R7, R8 is easy. Their ends may be bent over but still removal should not be difficult.

But removing the thermistor may be more difficult because one end may be soldered into the same hole as the 56 ohm resistor and the other end is soldered into a hole almost under the 56 ohm resistor.

When installing the new combination of thermistor and 34 ohms it may be simpler to just tack solder the left end (as viewed in the photo) of the combination to the junction post with the black wire soldered to it. This is the same electrical point as the hole almost under the 56 ohm resistor.

I find it quite possible to make these changes without removing the dial or needle. When working on the top side (as shown in the photo) the assembly is easily supported resting on its back side. But when working on the back side of the board, where the solder and circuit traces are, I find it very handy to support the tach on its dial face by setting it, face down, on the edges of a small box with no top- a small box like a jewelry box with its lid off. Set the tach so the dial face rests on the edges with the needle free to swing and pivot somewhat. Do not set the tach face down on the needle on a hard surface.

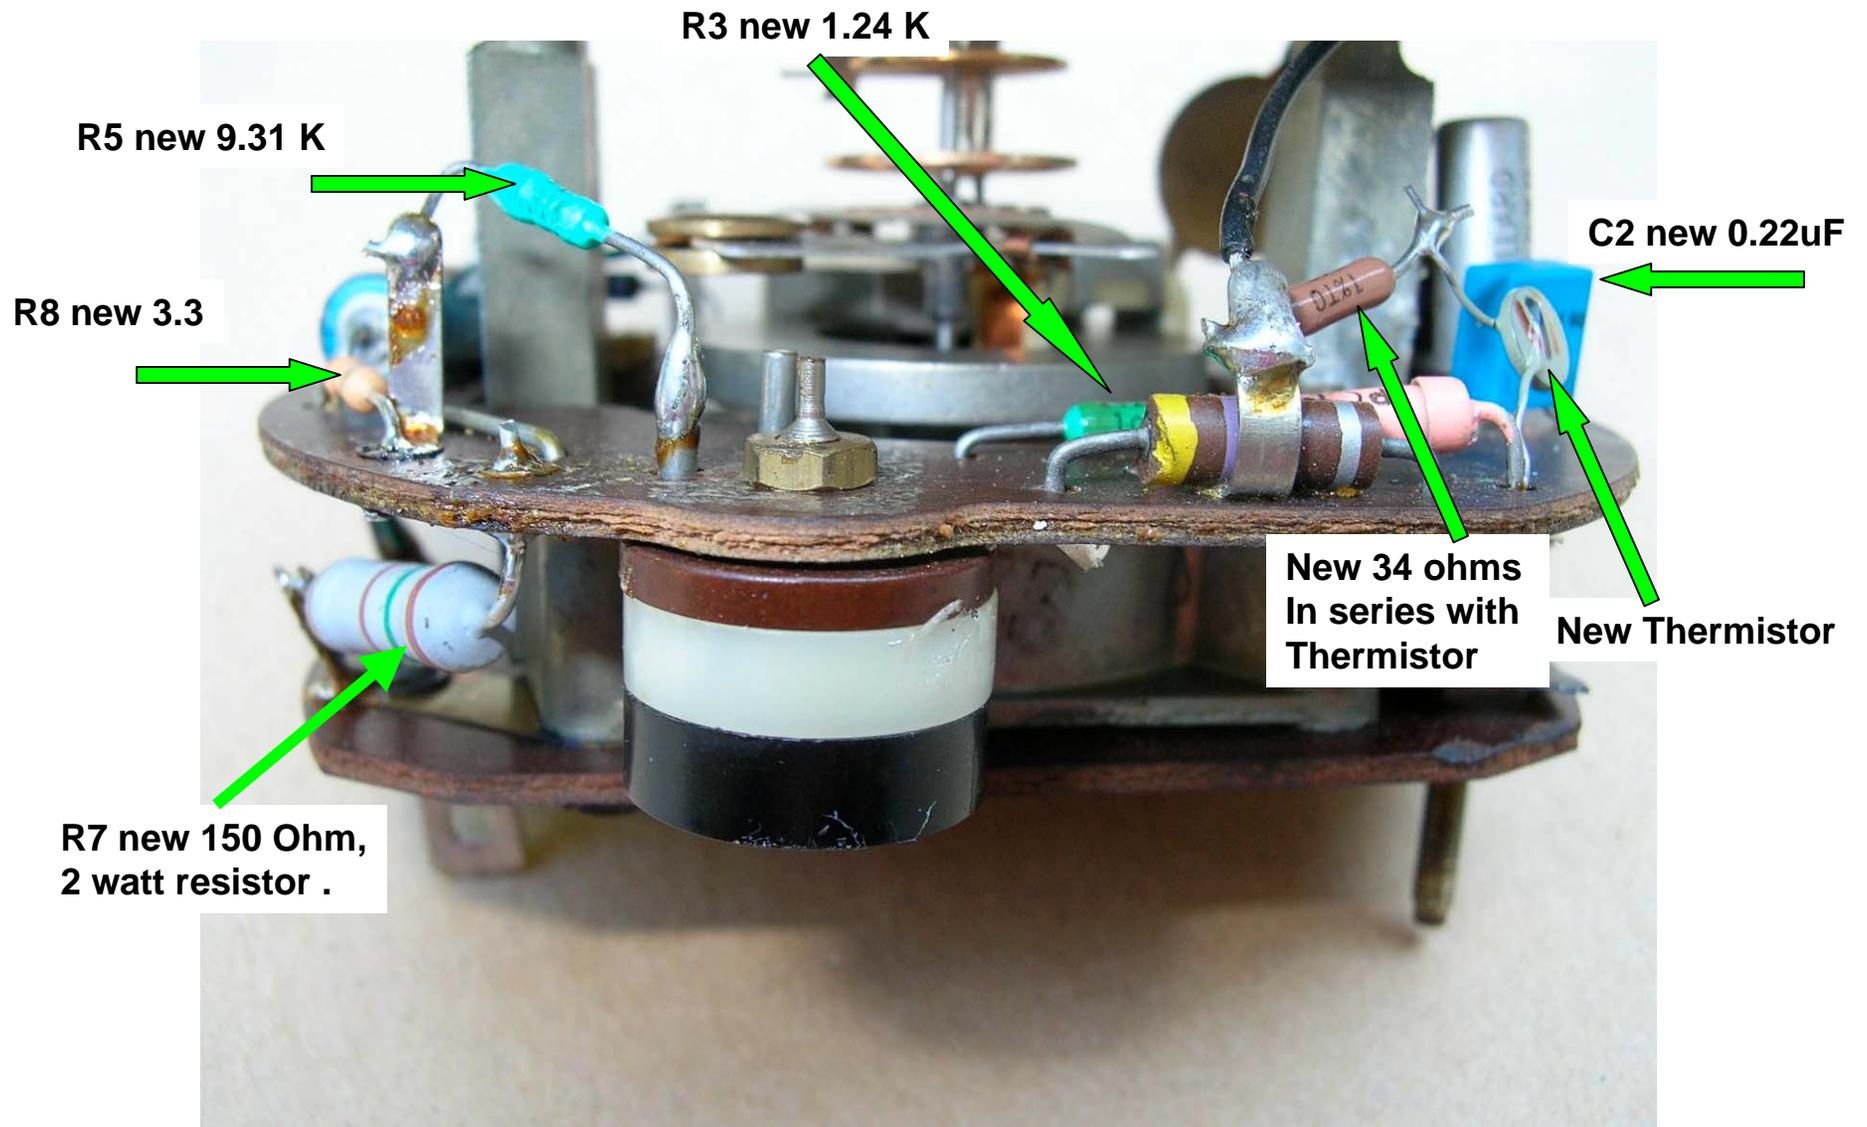
Upgraded assembly

The reason for replacing R5 with a 9.31k is to reduce the adjustment range of the adjuster and increase the stability of the timing. An old adjustable resistor as used in this tach is not very stable over time or temperature, so reducing its effect reduces the drift. This also reduces its adjustment range, which is not a problem as long as the tach is used for a 4 cyl engine. The value of this resistor is not critical. Any value from about 3k to 15k will probably be OK because the adjustable resistor sets the actual total resistance and the combination of C2 and this resistance determines the pulse width of the pulse train. But the resistor should be one with a good temperature stability. And the larger the value used for R5, the less resistance from the variable resistor is used, and the better the temperature stability of the pulse width and thus the overall accuracy.

It is also important to clean the assembly and the case. The clearances between the moving coil and the circular magnet are very close. In many tachs I have found metal shaving and almost always paint flakes. This debris will cause stickiness in the meter movement and results in inaccurate RPM readings. I use artists paintbrushes and Q-Tips dipped in alcohol to carefully clean everything.

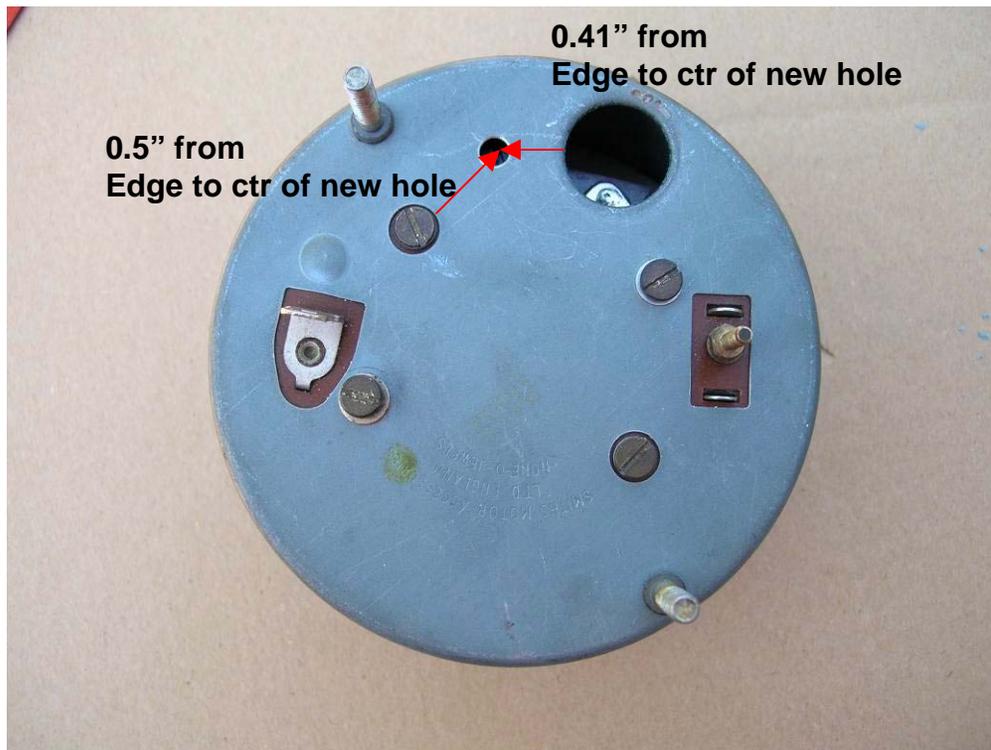
Before installing the assembly into the housing I suggest drilling a 3/16" (or so) hole in the rear of the case to provide access to the adjustment pot. This allows adjustment of the tach after it is mounted in the case. Otherwise there is a slight shift in calibration after mounting in the case.

Be sure to put tape or other means over the hole after calibration to keep out moisture, dirt, dust, and bugs

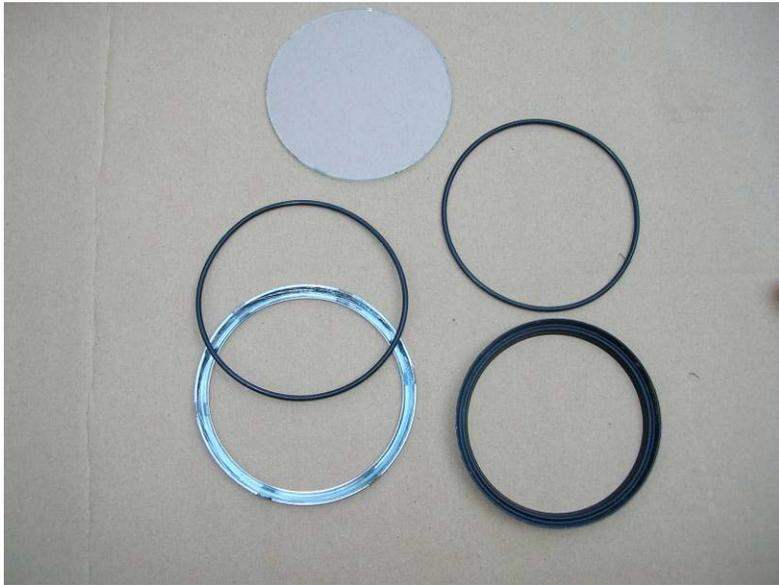
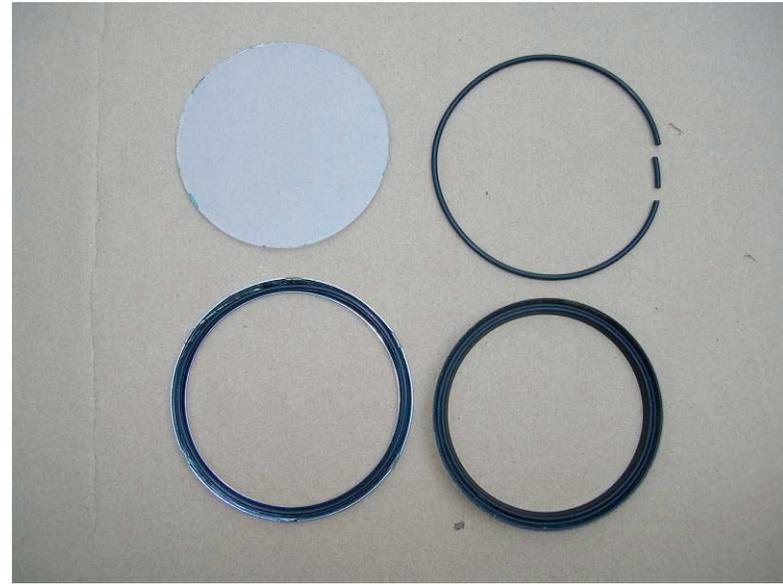
Use the 2 new thick (0.10") O rings to mount the glass and chrome ring. One ring fits exactly as is into the chrome ring.

The other O-Ring requires cutting out a segment (approx 1/2") to allow it to fit snugly into the bezel

There is a third O-Ring, thinner in cross section, that goes outside the case and acts a a gasket between the housing flange and the dash panel. These were installed on all Alpines, but I am not sure how necessary they are.

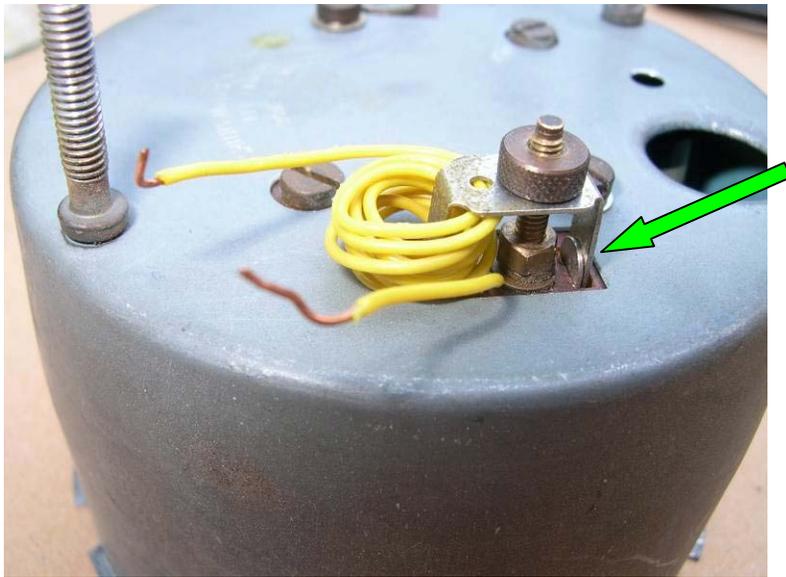
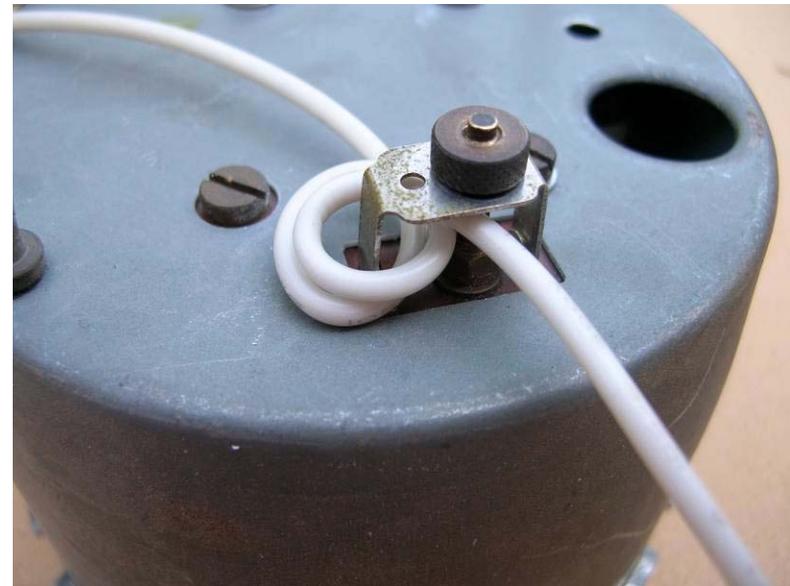
If you are using a signal generator (typically with 50 ohm or 600 ohm output impedance) to calibrate the tach you will need to wind 15 to 30 turns of small gauge wire around the U-shaped steel clip in order to couple a large enough signal in.

If you are using the actual ignition signal to calibrate the tach you can just wind a couple turns of the ignition wire through the clip. You do not need to use the plastic piece that is installed in the white wire. For some tachs I have seen a need to wind an extra turn, one more than the 1-1/2 turns originally used, in order to get the tach to respond. It's easy to do if you don't use the plastic piece.

Note that in order for the tach to respond to the ignition pulses, BOTH tips of the little U-shaped steel clip must be in good contact with the mating tip protruding through the case from the other half of the transformer inside.

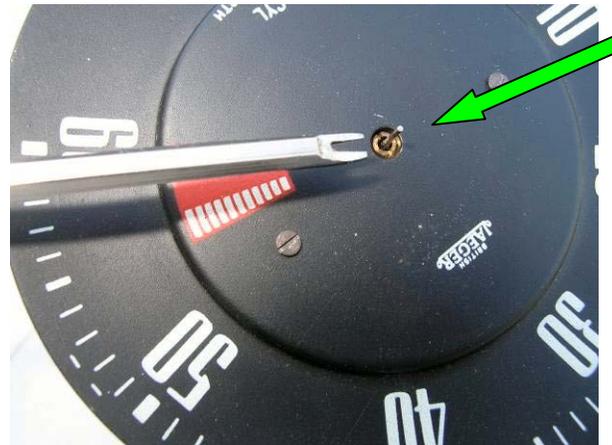
I have seen several cases where the needle seemed a bit sticky. That is, it did not move smoothly over the full range of indications. I have read various posts by other Alpine owners about similar problems. Assuming you have cleaned the mechanism and especially the area around the magnet and moving coil, I have found that in most cases this is a case of insufficient end play in the needle pivot. If you have a sticky needle, grab the center “knob” of the needle and push-pull it in and out from the dial. It should have some slight play (about 0.003”), just enough to be observable. If there is no end play you can adjust the end bushing. First remove the needle. I find the best way to remove the needle is by using a pair of small jewelers screwdrivers inserted from opposite sides with their tips touching the dial under the needle “knob” where any scratches from the tips will not show after the needle is reinstalled. Pry evenly on both sides and the needle will pop off. Once the needle is off you need to use a split tip screwdriver as shown in the picture. You can make one by grinding a slot in the tip of a regular, small screwdriver

The slot does not need to be as deep as the needle pivot since you can make the adjustment with the screwdriver at an angle. You’ll only need to turn the adjustable bushing about 1/8 of a turn to make it loose enough to eliminate sticking.

When replacing the needle just press it on to the pivot pin. Initially install it slightly above the “0” position and don’t press it on very hard. Then rotate it into final position at “0” and then press it a bit more firmly on with just finger pressure .

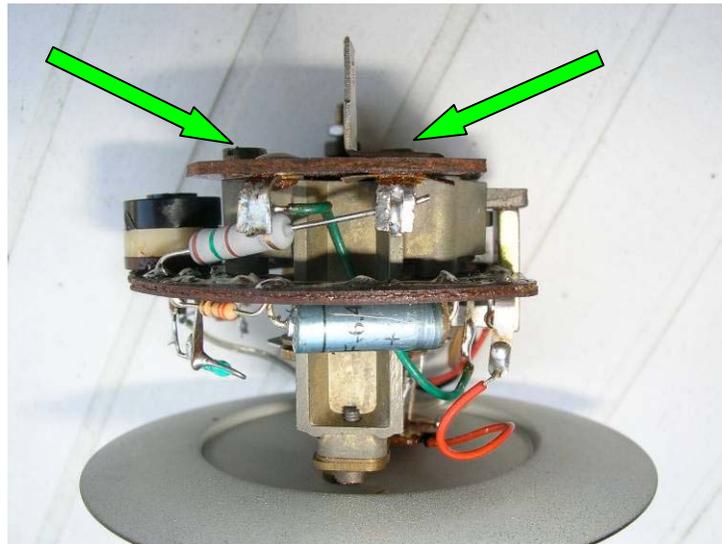
Tach wired for Positive Earth

The 2404/00A and 2404/00B fitted to later SIVs are nearly identical to the 2411/01 described in this article except for the values of R6 and R7, which are not critical, and for the fact that they are wired as Positive earth. The photo shows what a Pos earth wired unit looks like. In fact this is the electronics from a 2411/01 Neg earth, SV tach, that has been re-wired to be Pos earth. The only differences are the swapping of the green wire and the end of the large resistor, R7. If you have a 2404/00A or 2404/00B and wish to convert it to Neg earth simply swap the 2 connections, moving the end of the resistor to the tab on the left and moving the green wire to the tab on the right (R&L as viewed in this photo)
